Manhole Inspection Summary

Manhole # S11KK1023MH

Location Address: **4646 PARK HEIGHTS AVE**

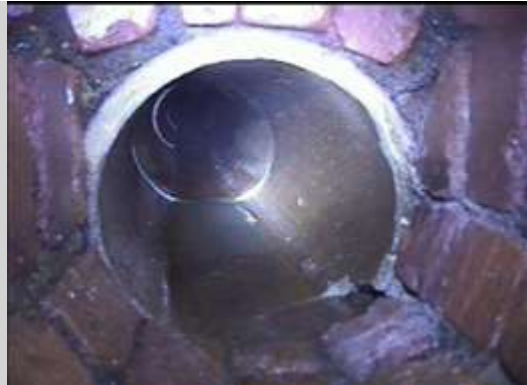
12 O'Clock Outflow

8 in. Circular Gravity Sewer
Pipe Out @ 12 O'Clock

Pipe Height: **4.8** (in.) Rod and Bar
Pipe Material: **Clay** ☐ Pipe Lined
Invert Depth: **13.05** (ft.) Flow Characteristics: **Slow**
Deposits: ☒ None ☐ Mud ☐ Sludge ☐ Debris ☐ Grease
Silt Depth: (in.) Deposits Extent:
Infiltration: **None** Pipe Seal Cond: **Cracked**

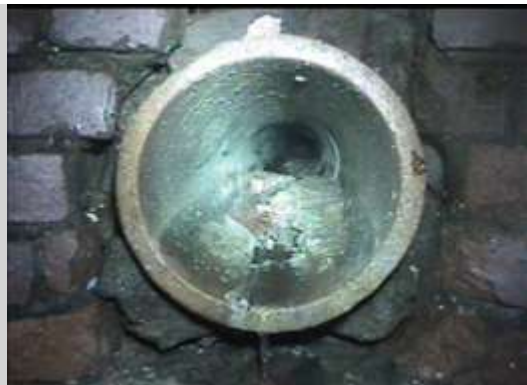
6 O'Clock Inflow

8 in. Circular Gravity Sewer
Pipe In @ 6 O'Clock

Pipe Height: **7.2** (in.) Rod and Bar
Pipe Material: **Clay** ☐ Pipe Lined
Invert Depth: **12.39** (ft.) Flow Characteristics: **Slow**
Deposits: ☐ None ☐ Mud ☐ Sludge ☒ **Debris** ☐ Grease
Silt Depth: **1** (in.) Deposits Extent: **Light**
Infiltration: **None** Pipe Seal Cond: **Sound**

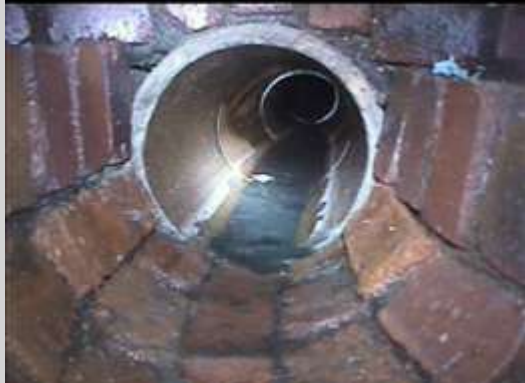
9 O'Clock Inflow

8 in. Circular Gravity Sewer

Pipe In @ 9 O'Clock

Pipe Height: **6** (in.) Rod and Bar

Deposits: ☒ None ☐ Mud ☐ Sludge ☐ Debris ☐ Grease

Infiltration: **None** Pipe Seal Cond: **Sound**
